MD 787 (Flower Avenue) Traffic Calming Study

September 2003

I. Introduction

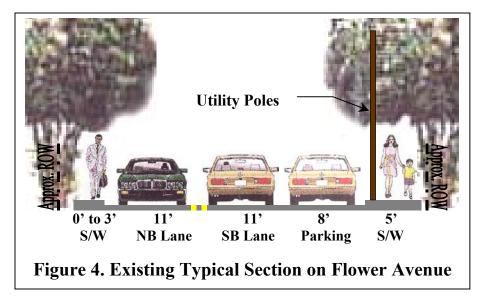
A 5-foot wide, concrete sidewalk exists along the western side of MD 787. There is a sidewalk on the eastern side of MD 787 for approximately ½ of the corridor. The sidewalk is mostly

asphalt and varies in width between several inches and 3 feet. Overhead aerial lines and utility poles (power, telephone, cable) are located along the west side of the roadway.

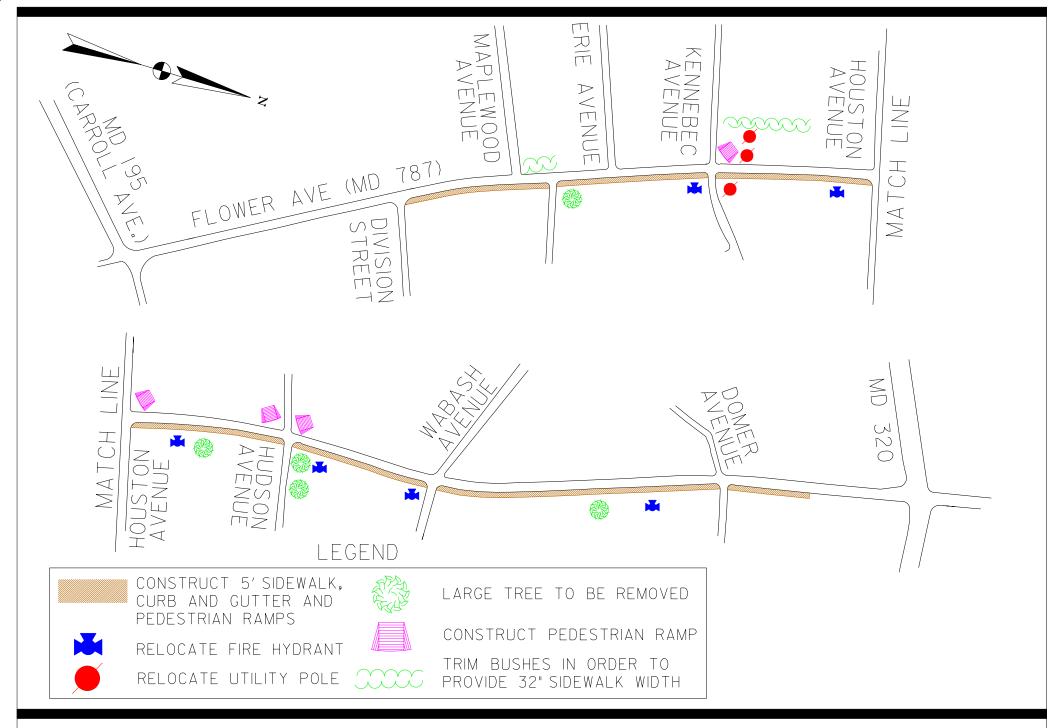
Figure 7

The most significant issue is the lack of an acceptable sidewalk on the east side of MD 787. The sidewalk is missing in large sections; where there is a sidewalk there are vertical elevation differences greater than ½ inches and/or there are obstructions reducing the sidewalk width to less than 32 inches. Pedestrian ramps are missing at all but 3 locations on the east side.

Recommended Sidewalk Improvements

The existing sidewalk should be removed and a new sidewalk should be constructed on the east side of the roadway. Except for a few locations, the sidewalk on the west side meets the requirements listed above. **Figure 7** illustrates the minimum recommended sidewalk improvements.
